**Subject: Letter Report on Emergency Response and Removal Activities
Sealmore Corporation
Muskegon, Muskegon County, Michigan
Technical Direction Document No. S05-0306-001
Tetra Tech Contract No. 68-W-00-129**

**LETTER REPORT ON
EMERGENCY RESPONSE AND
REMOVAL ACTIVITIES
SEALMORE CORPORATION
MUSKEGON, MUSKEGON COUNTY, MICHIGAN**

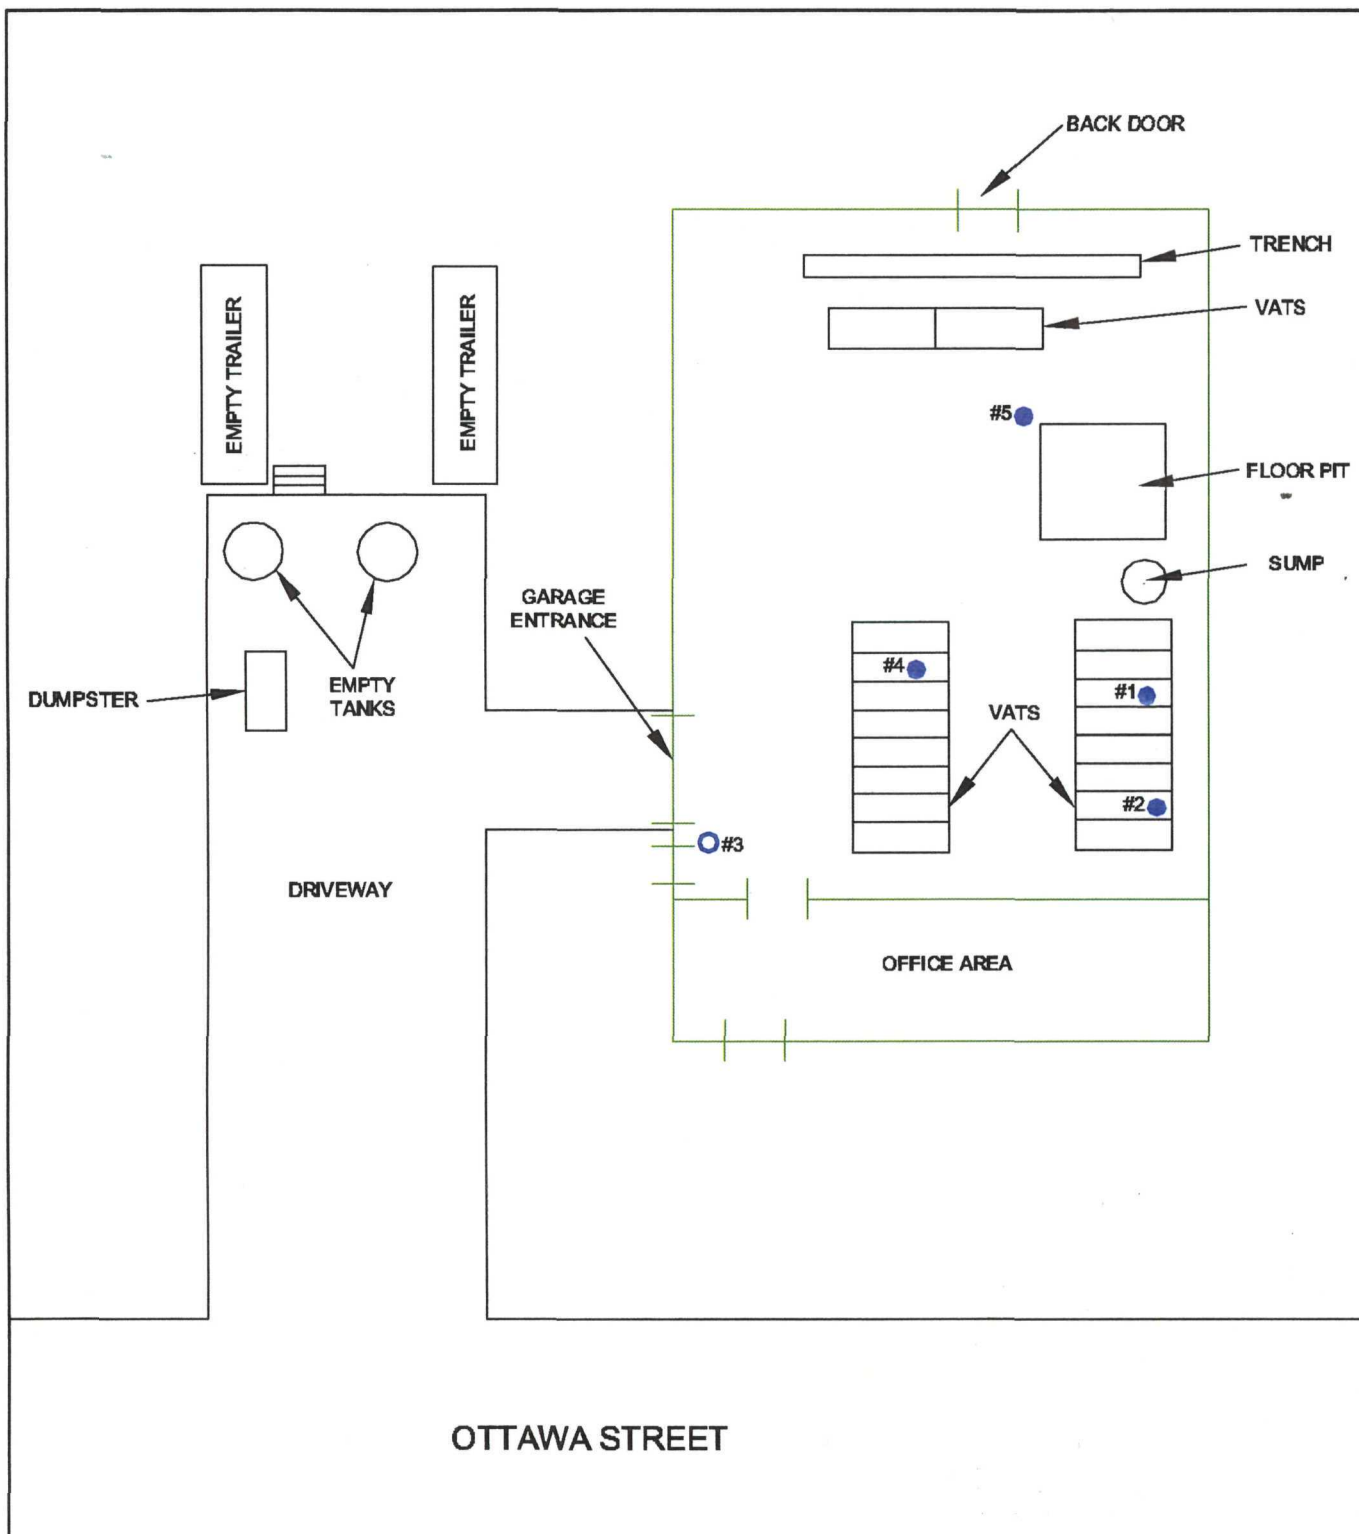
FIGURE 2
SITE LAYOUT AND
SAMPLING LOCATION MAP

On June 5, 2003, U.S. EPA and START mobilized to the Sealmore site, met with RRD, and conducted an initial walk-through of the site in Level B personal protection equipment. Figure 2 shows features observed by START. The site building was dilapidated, and overhead hazards were evident from the collapsed roofing. Rain had significantly damaged areas underneath the leaking roof. Green staining was observed near the garage entrance, indicating potential off-site migration of contaminated material from the site, which could reach storm drains that empty into Lake Muskegon. Lake Muskegon is directly connected by a channel to Lake Michigan. Outside the building, START observed two empty trailers northwest of the building with 11 empty and partially full drums under them as well as two empty steel tanks.

Inside the building, START observed containers and drums located throughout the building that were leaking, with visible pooling and staining; one open floor pit; 16 small and 2 large processing vats located in the eastern and western portions of the building, respectively; a sump; and a trench in the western part of the building containing clear liquid.

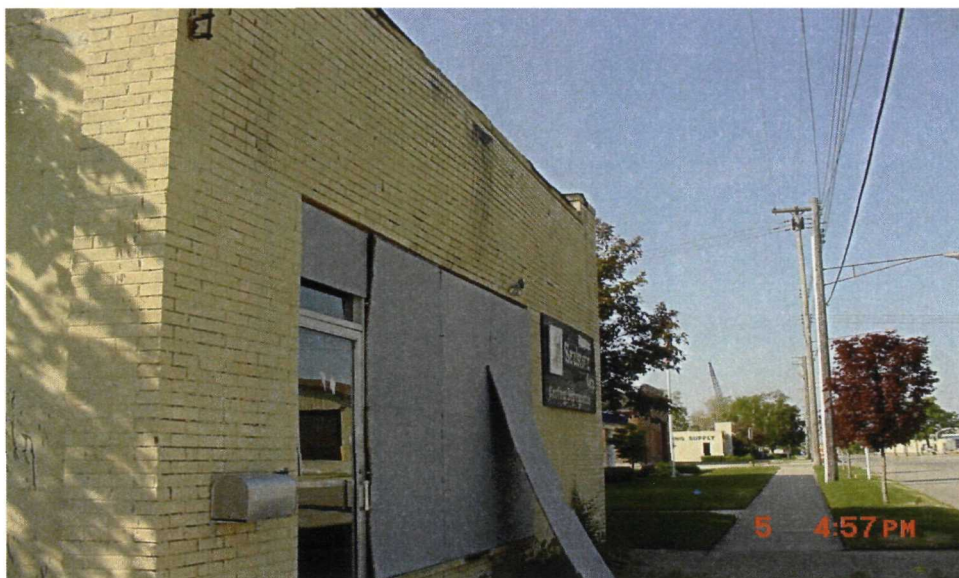
Photograph No.: 1
TDD No.: S05-0306-001
Location: Sealmore Corporation Site
Subject: Bulging brick on eastern wall of on-site building

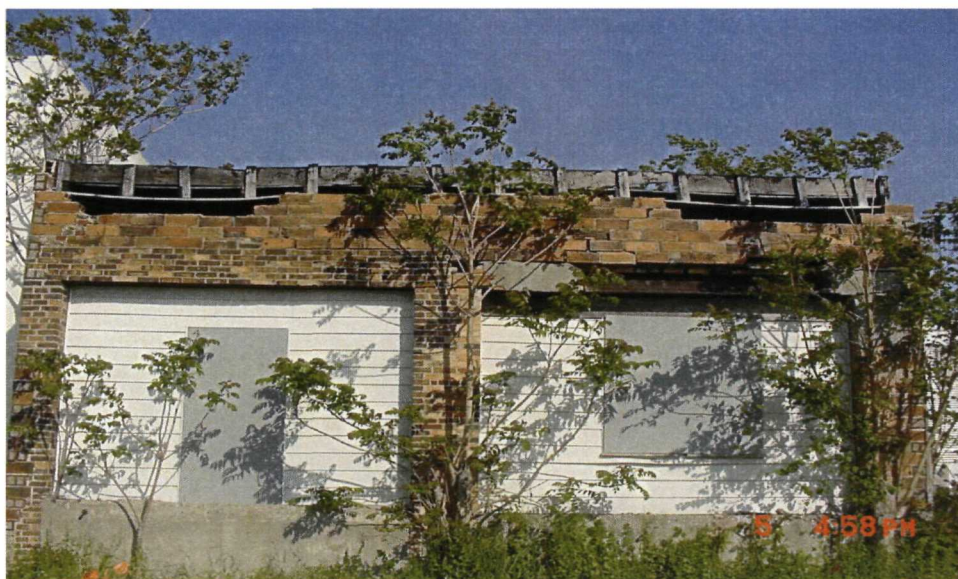
Photograph No.: 2
TDD No.: S05-0306-001
Location: Sealmore Corporation Site
Subject: Western wall of on-site building

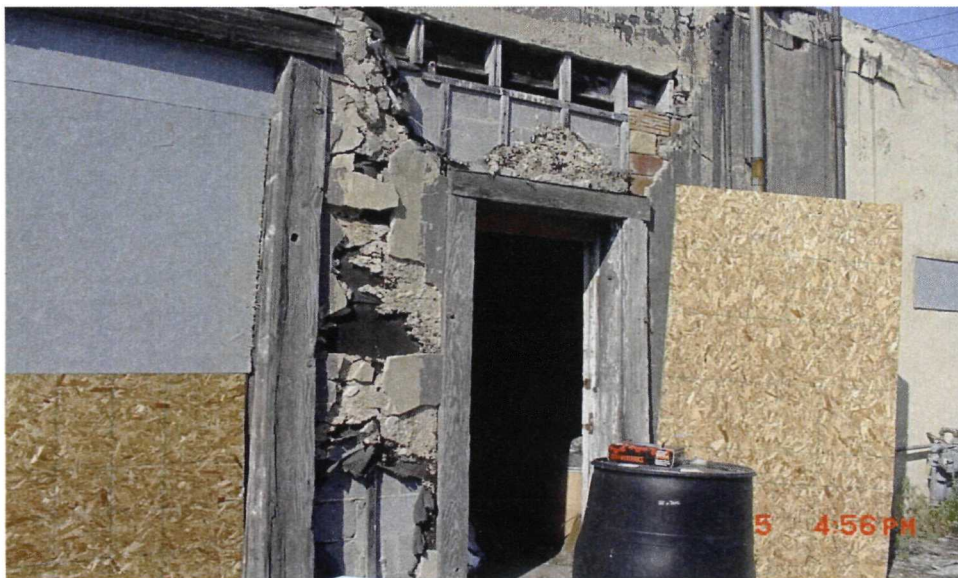
Photograph No.: 3
TDD No.: S05-0306-001
Location: Sealmore Corporation Site
Subject: South entrance to building

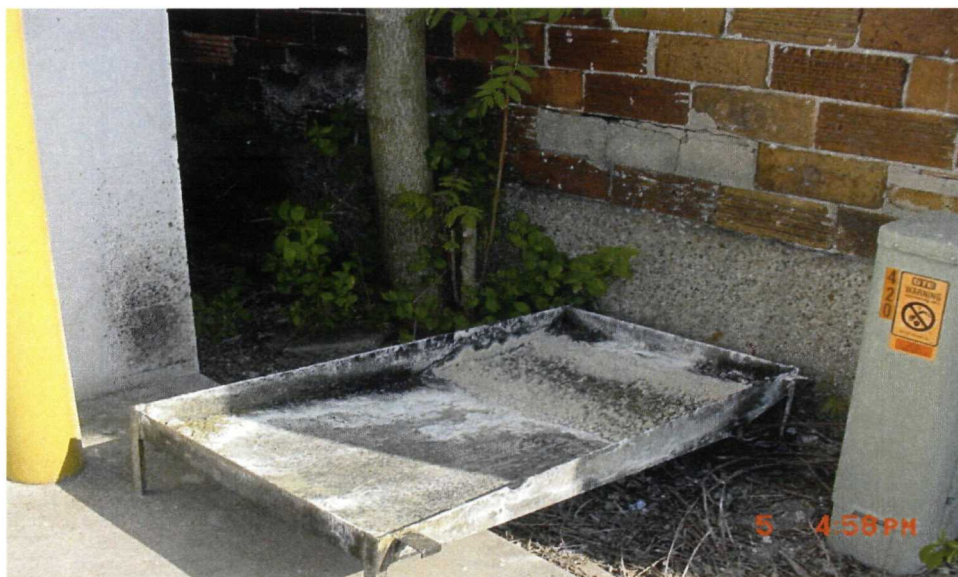
Photograph No.: 4
TDD No.: S05-0306-001
Location: Sealmore Corporation Site
Subject: Drip pan located on north side of building

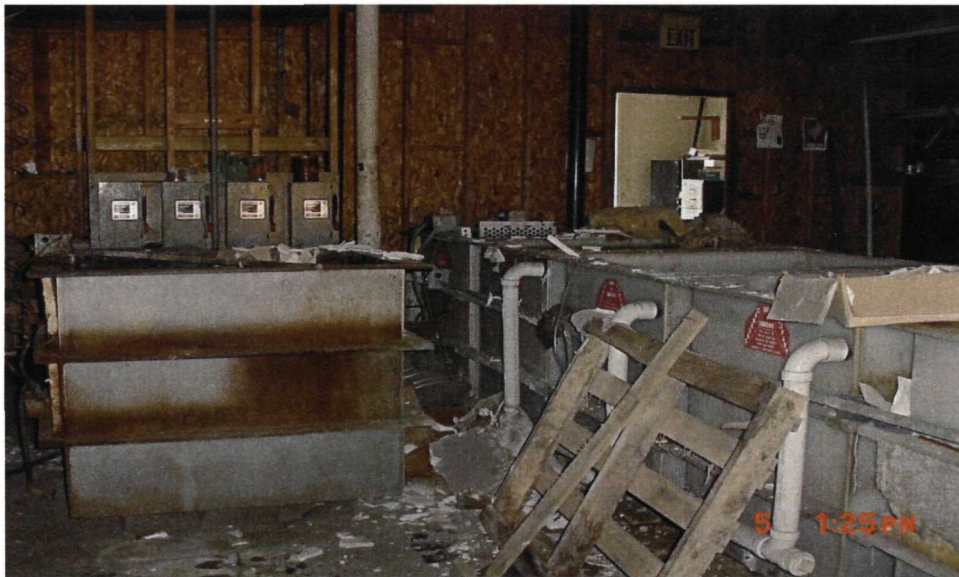
Photograph No.: 5
TDD No.: S05-0306-001
Location: Sealmore Corporation Site
Subject: Plating vats located inside building

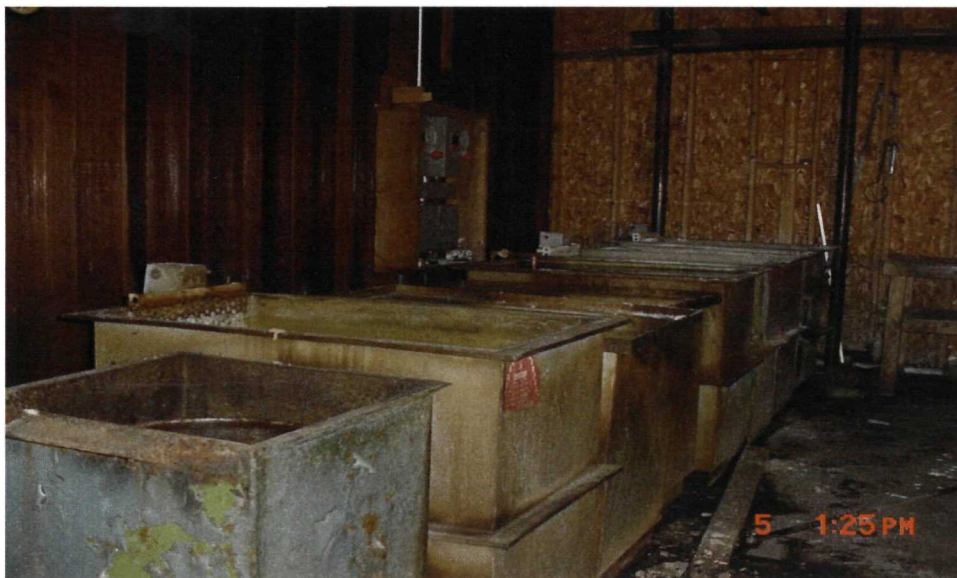
Photograph No.: 6
TDD No.: S05-0306-001
Location: Sealmore Corporation Site
Subject: Plating vats located inside building

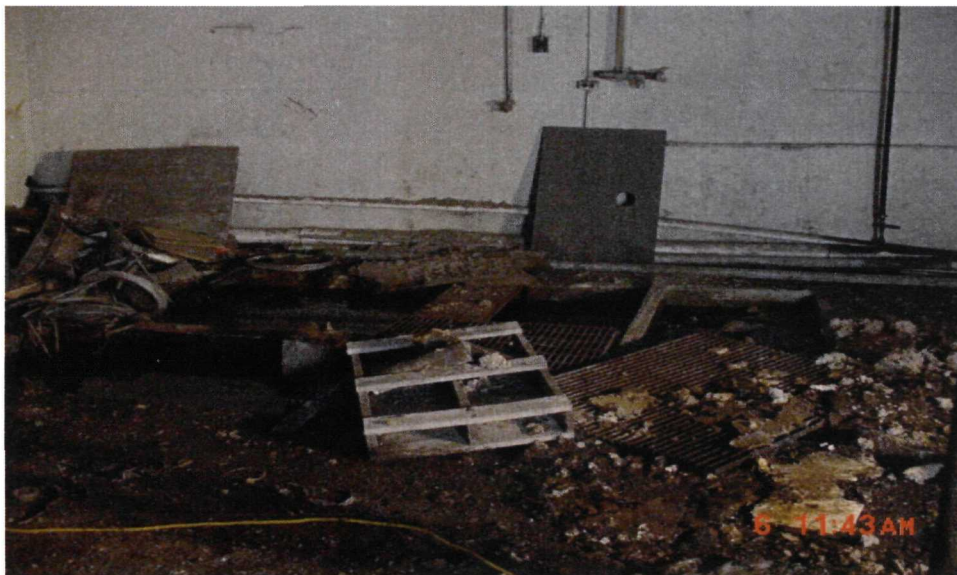
Photograph No.: 9
TDD No.: S05-0306-001
Location: Sealmore Corporation Site
Subject: Floor pit located in northern portion of building

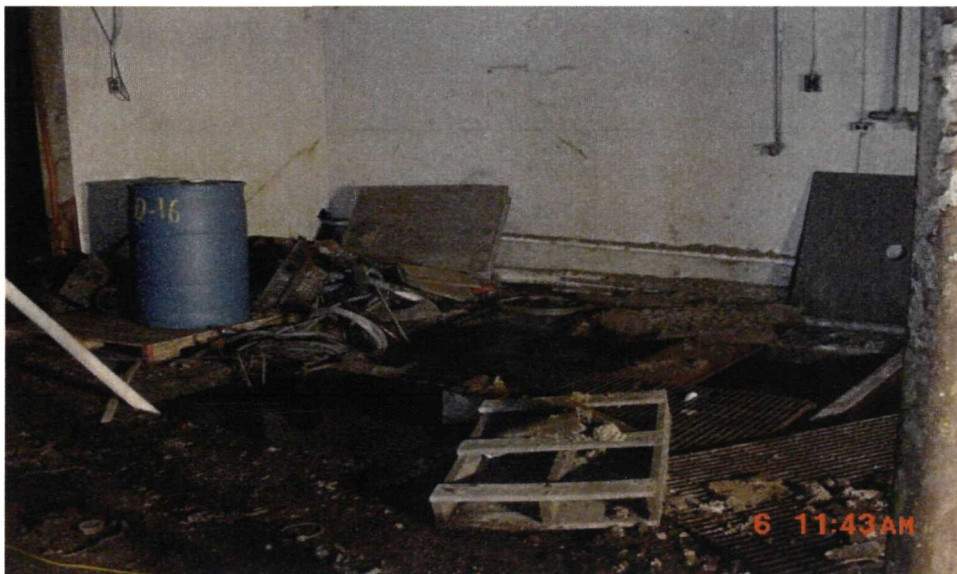
Photograph No.: 10
TDD No.: S05-0306-001
Location: Sealmore Corporation Site
Subject: Floor pit located in northern portion of building near hydrofluoric acid drum

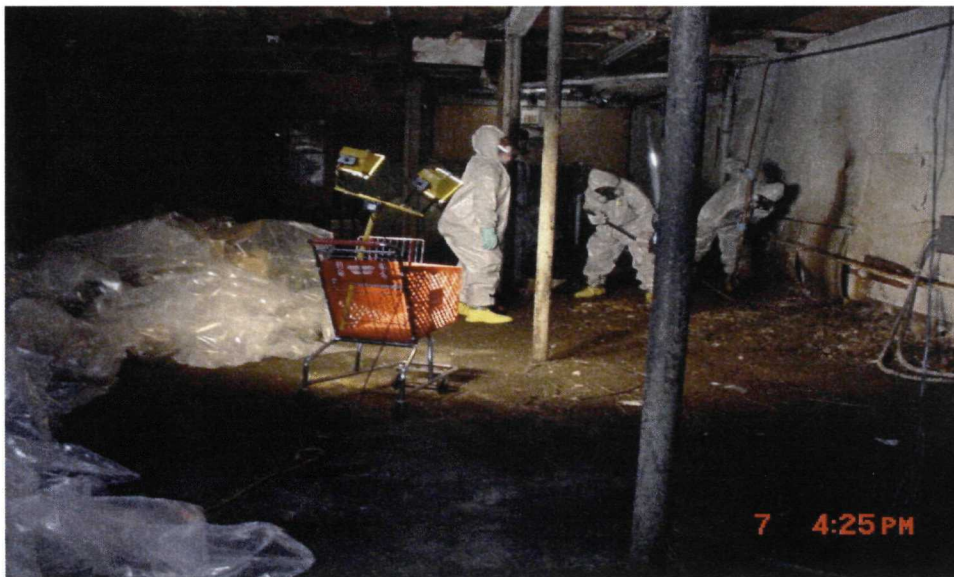
Photograph No.: 11
TDD No.: S05-0306-001
Location: Sealmore Corporation Site
Subject: Removal of floor material

On June 7, 2003, the ERRS contractor continued removing debris and spilled material from the floors. The collected material was placed in 55-gallon drum liners and staged in the building. Hazcatting of samples and waste stream determination was completed. The following preliminary waste streams were identified: chromic acid liquids, chromic acid solids, acid liquids, acid solids, caustic liquids, caustic solids, neutral liquids, neutral solids (including floor material), flammable liquids, and hydrofluoric acid.

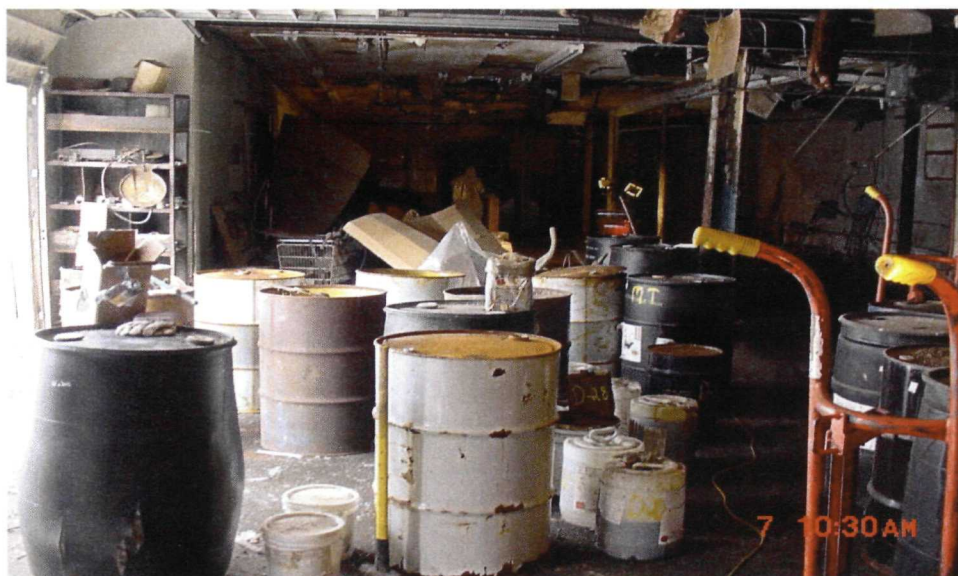
Photograph No.: 12
TDD No.: S05-0306-001
Location: Sealmore Corporation Site
Subject: Staged drums and containers

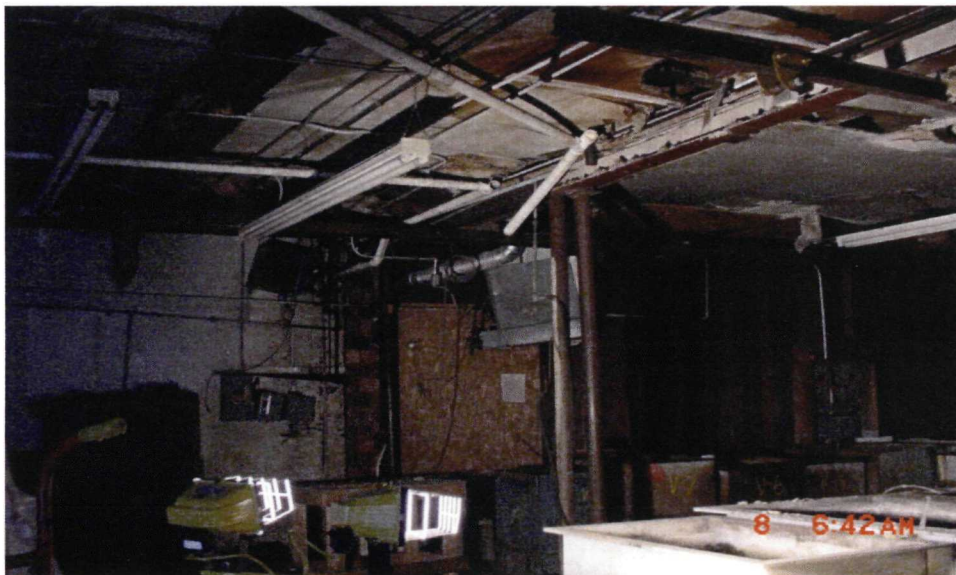
Photograph No.: 13
TDD No.: S05-0306-001
Location: Sealmore Corporation Site
Subject: Ceiling material collapsing

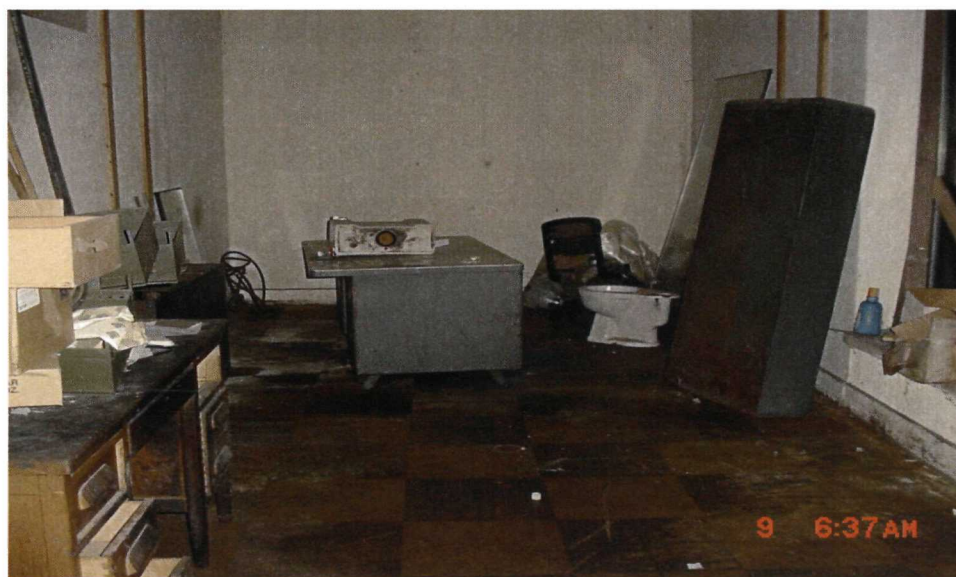
Photograph No.: 14
TDD No.: S05-0306-001
Location: Sealmore Corporation Site
Subject: Office located on southeast side of building

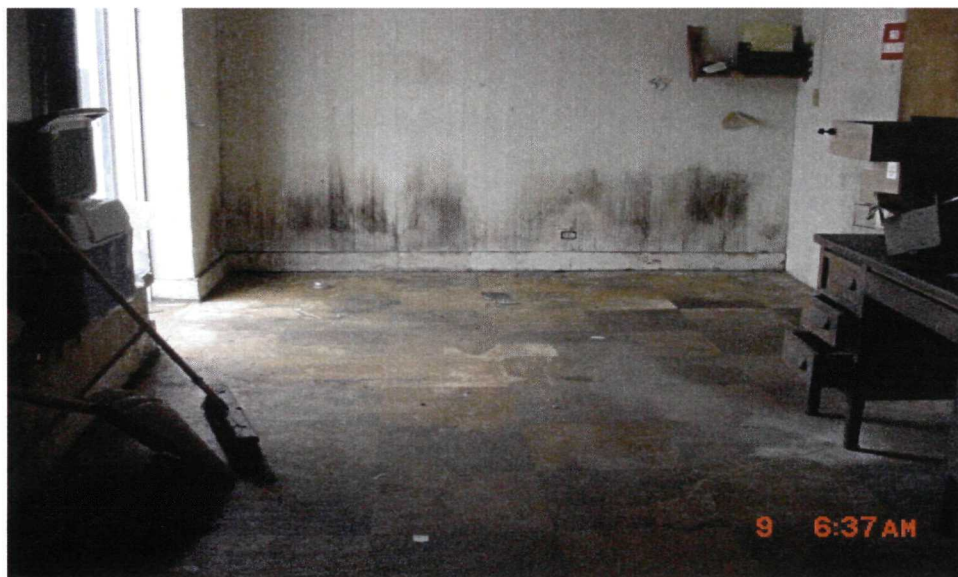
Photograph No.: 15
TDD No.: S05-0306-001
Location: Sealmore Corporation Site
Subject: Debris and equipment removed from office

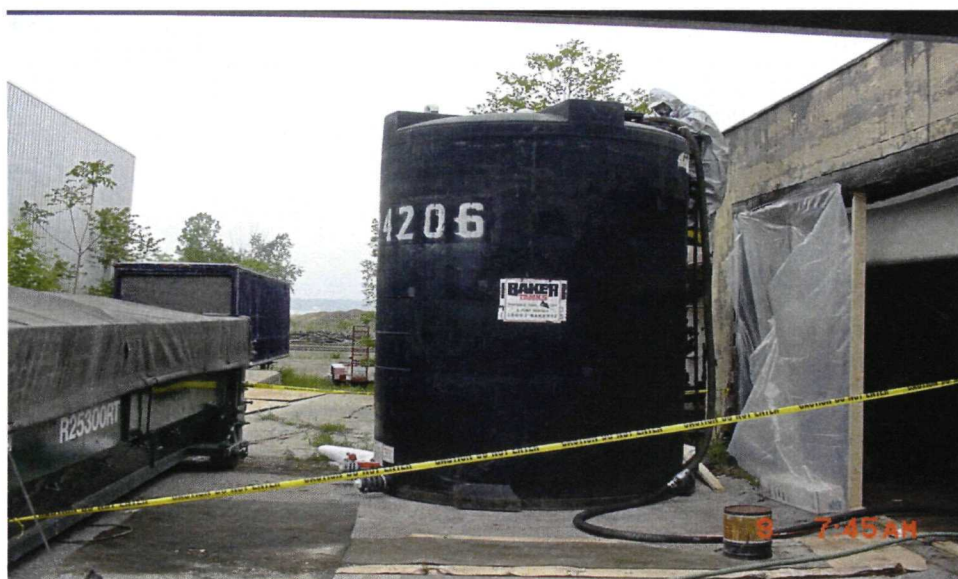
Photograph No.: 16
TDD No.: S05-0306-001
Location: Sealmore Corporation Site
Subject: 4,000-gallon polyethylene tank

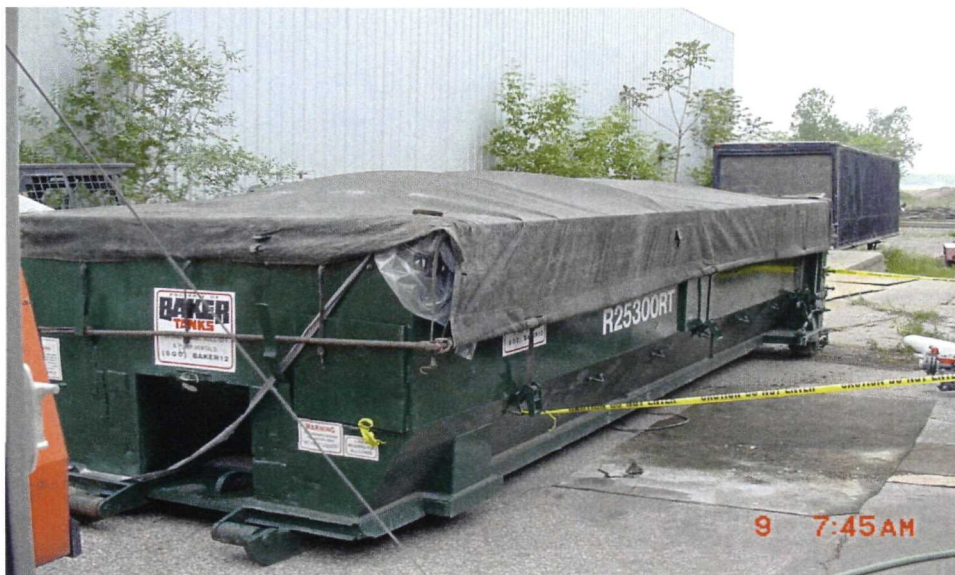
Photograph No.: 17
TDD No.: S05-0306-001
Location: Sealmore Corporation Site
Subject: Roll-off box for waste material

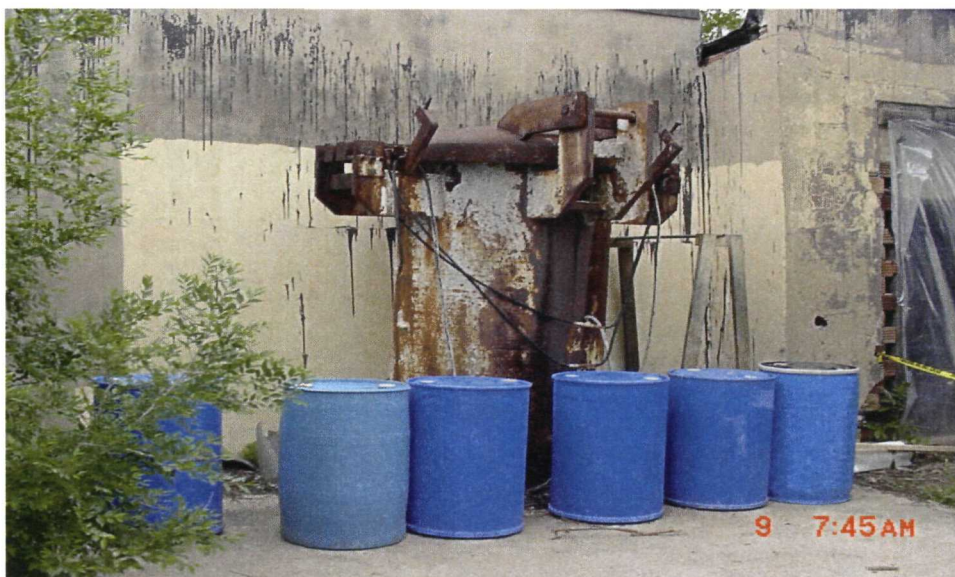
Photograph No.: 18
TDD No.: S05-0306-001
Location: Sealmore Corporation Site
Subject: Overpacked drums for building wastes

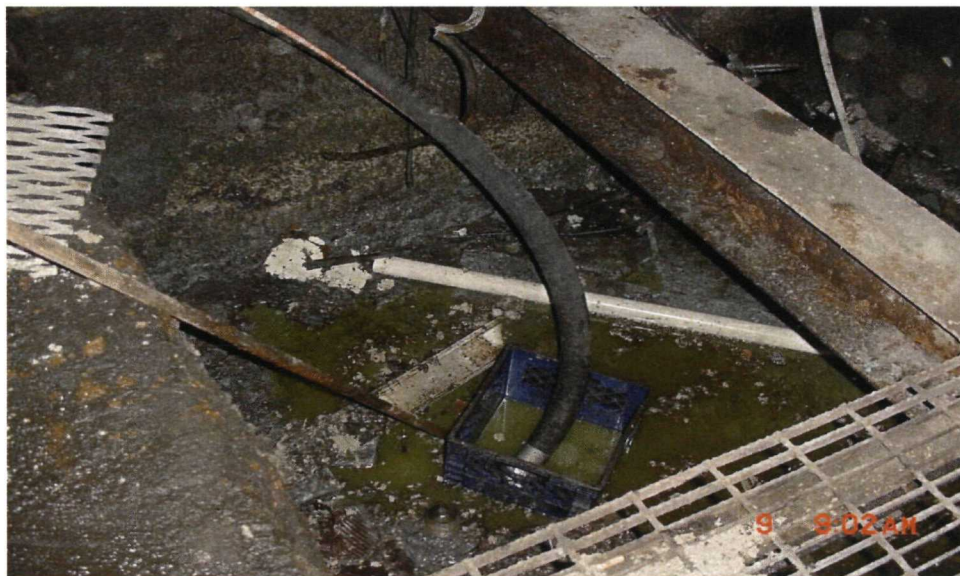
Photograph No.: 20
TDD No.: S05-0306-001
Location: Sealmore Corporation Site
Subject: Floor pit and debris

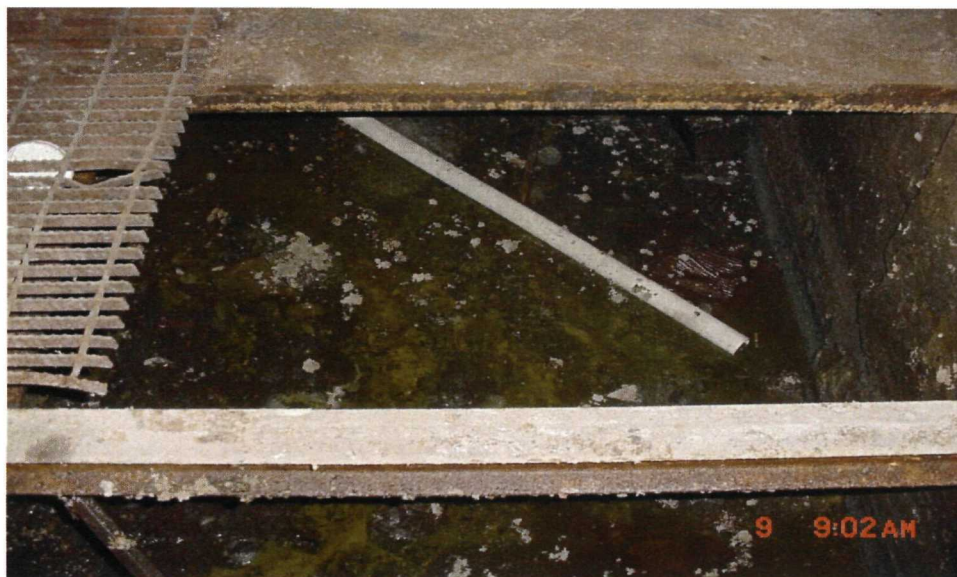
Photograph No.: 21
TDD No.: S05-0306-001
Location: Sealmore Corporation Site
Subject: Floor pit and debris

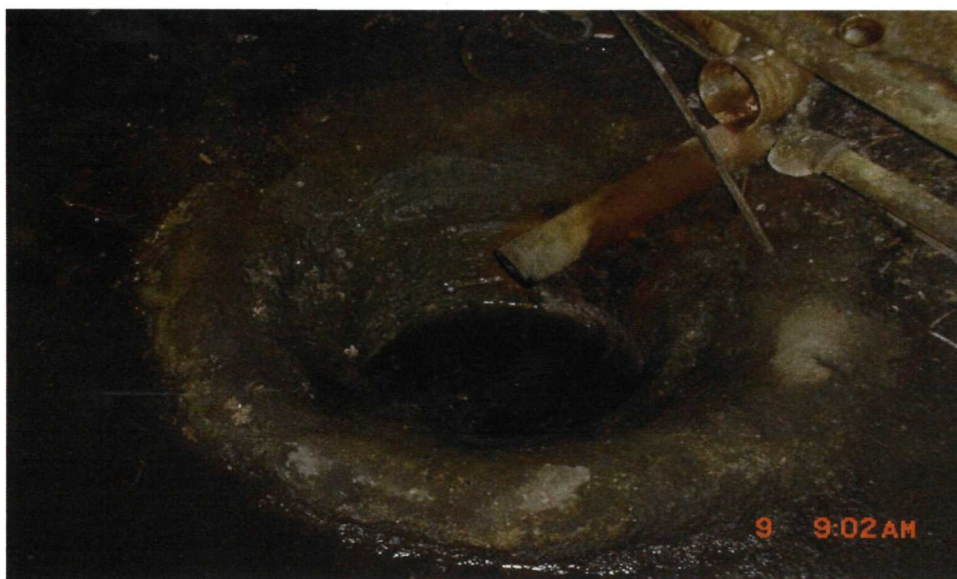
Photograph No.: 22
TDD No.: S05-0306-001
Location: Sealmore Corporation Site
Subject: Sump located near floor pit

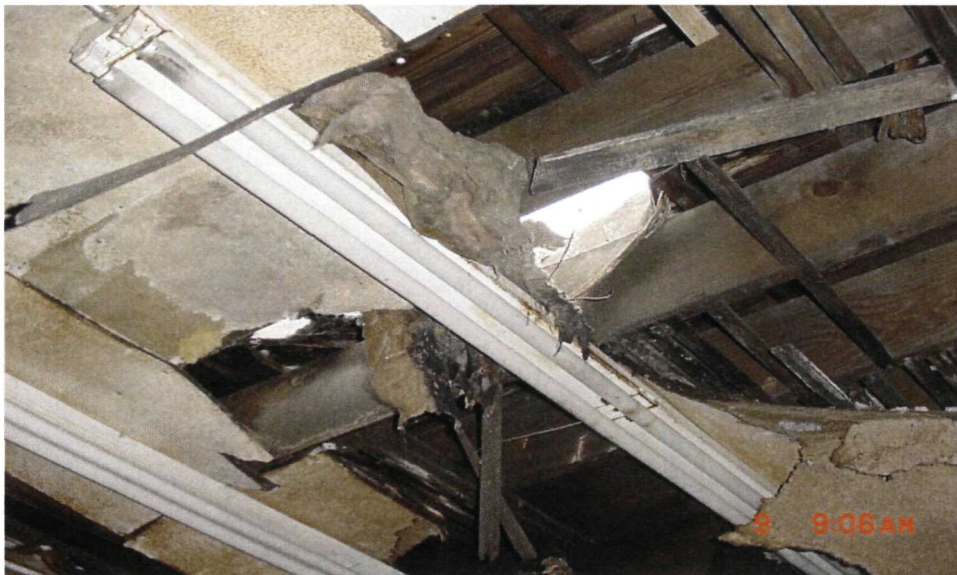
Photograph No.: 23
TDD No.: S05-0306-001
Location: Sealmore Corporation Site
Subject: Hole in roof

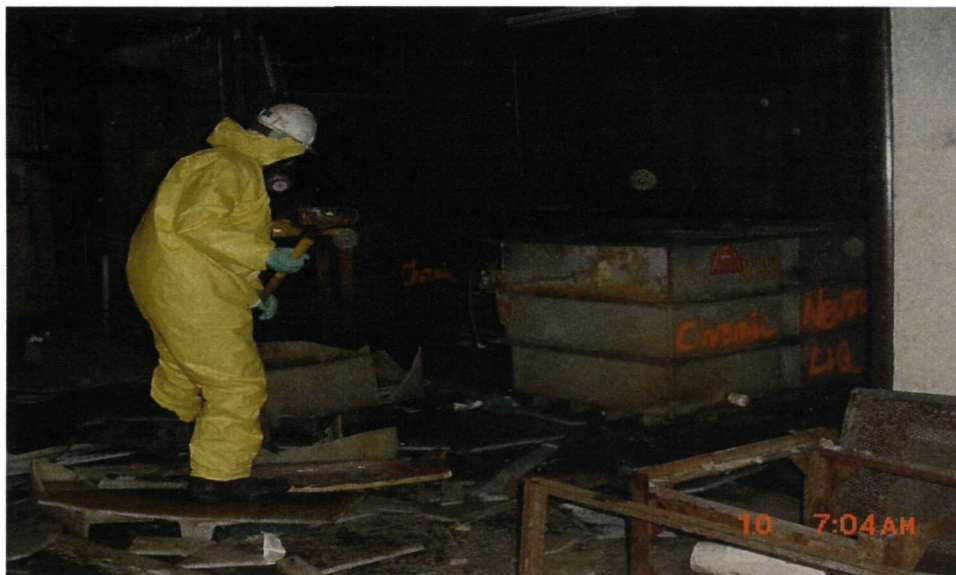
Photograph No.: 24
TDD No.: S05-0306-001
Location: Sealmore Corporation Site
Subject: Removal of material from vats

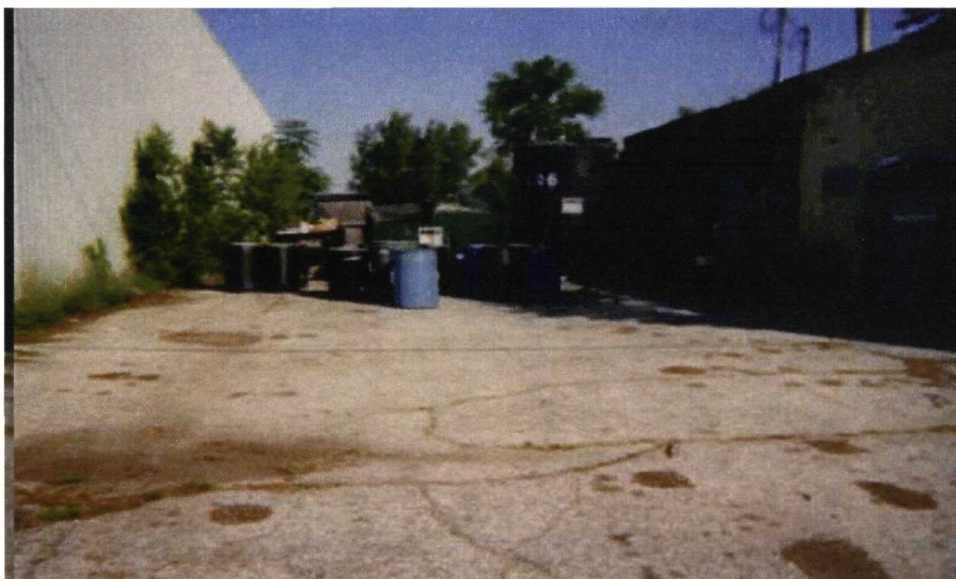
Photograph No.: 25
TDD No.: S05-0306-001
Location: Sealmore Corporation Site
Subject: Drums staged for transportation and disposal

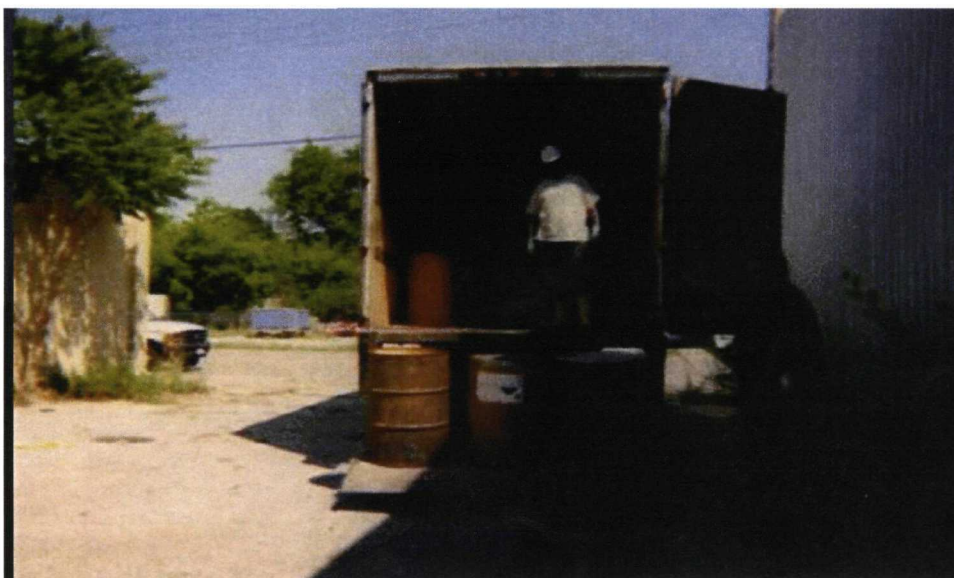
Photograph No.: 26
TDD No.: S05-0306-001
Location: Sealmore Corporation Site
Subject: Loading of drums and empty containers on truck for off-site transportation

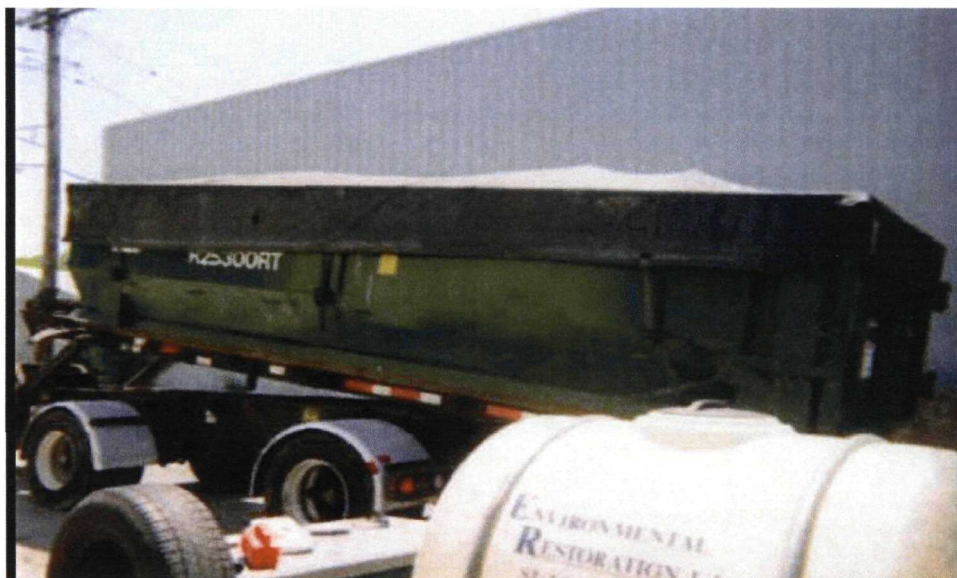
Photograph No.: 27
TDD No.: S05-0306-001
Location: Sealmore Corporation Site
Subject: Roll-off box transported off site to disposal facility

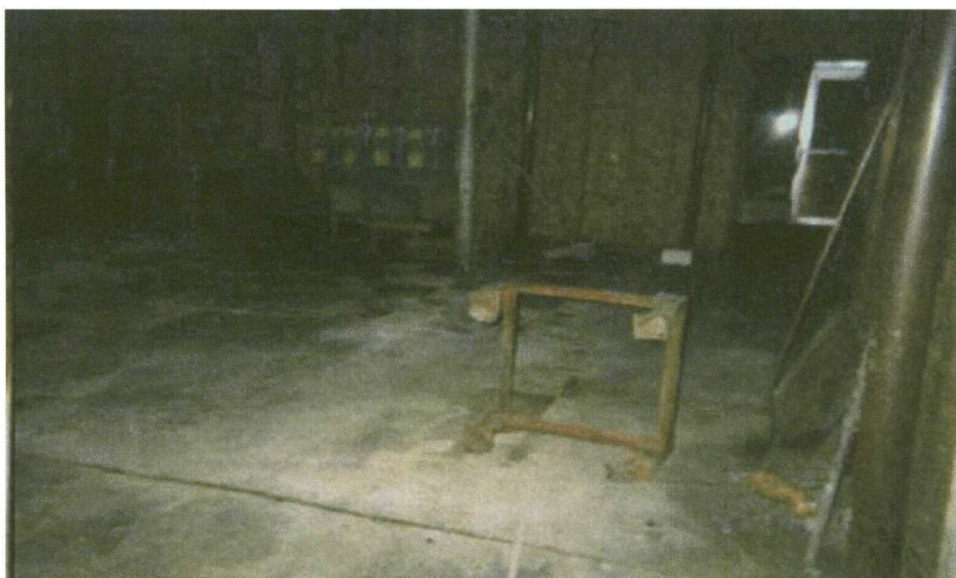
Photograph No.: 28
TDD No.: S05-0306-001
Location: Sealmore Corporation Site
Subject: Building after vats removed and floor power-washed

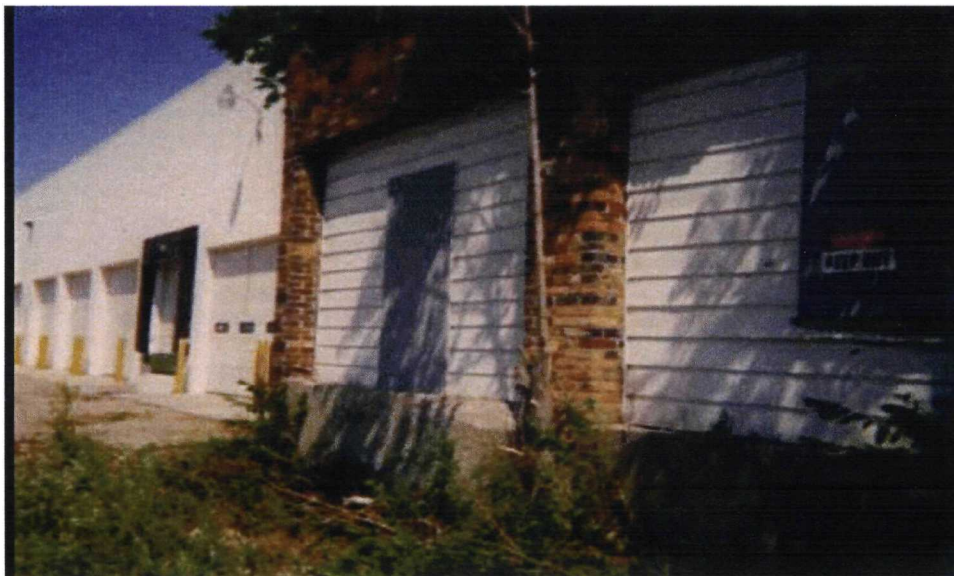
Photograph No.: 29
TDD No.: S05-0306-001
Location: Sealmore Corporation Site
Subject: Secured back door of building

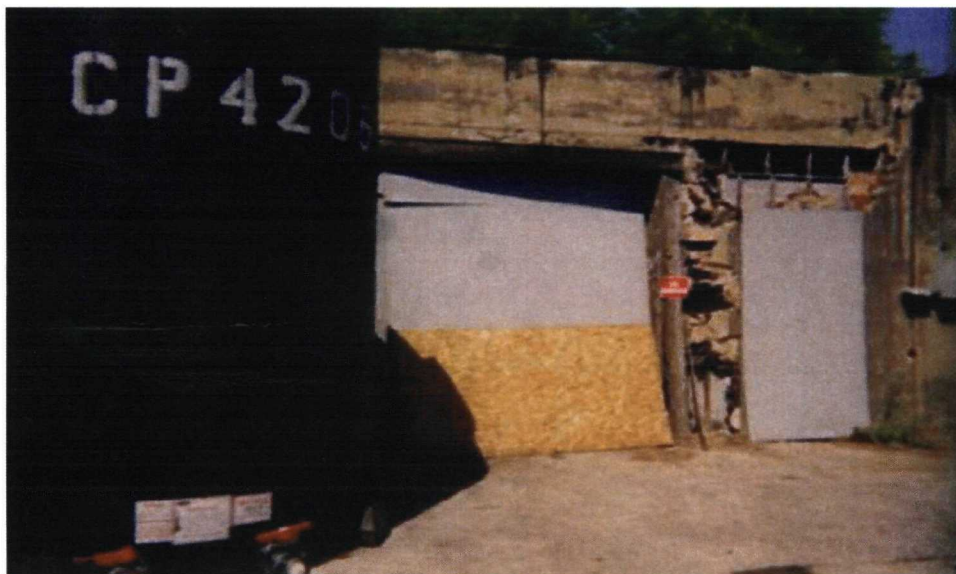
Photograph No.: 30
TDD No.: S05-0306-001
Location: Sealmore Corporation Site
Subject: Secured garage door
